# 試驗報告

報告編號: TV-23-02399 數: 1 OF 2

稱: PPR 水管 產 00 號: SDR11 產 品 型 產製供 00 顏 色: 藍

爆破水壓試驗

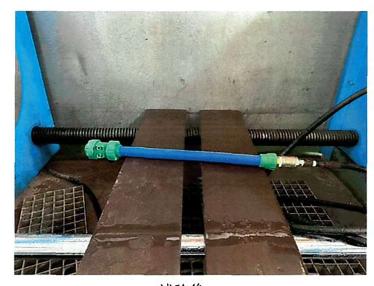
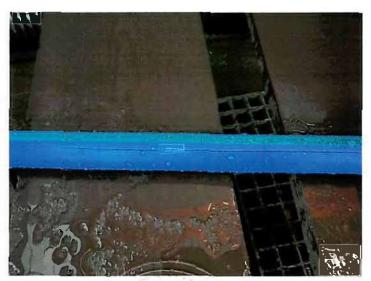
破裂狀態

試驗項目	試驗結果	
爆破水壓壓力(kgf/cm²)	65.7
