## 試驗報告

報告編號：TV-23-02147

產	品	名	稱：	PPR 水管
產	品	型	號：	SDR11
產	品	顏	色：	藍
製	造	廠	商：	Polymelt
供	應	廠	商：	昕澄國際有限公司
送	驗	廠	商：	昕澄國際有限公司
收	件	日	期：	112 年 06 月 05 日
試	驗	日	期：	112 年 06 月 05 日~112 年 07 月 04 日
備		註：	1.以上資料(送驗廠商、收件日期及試驗日期除外)及 下述報告內容標示#處係由顧客提供 2.除非另有說明，此報告結果僅對測試之樣品負責 未經本公司事先書面同意，此報告不可部分複製

#### 爆破水壓試驗

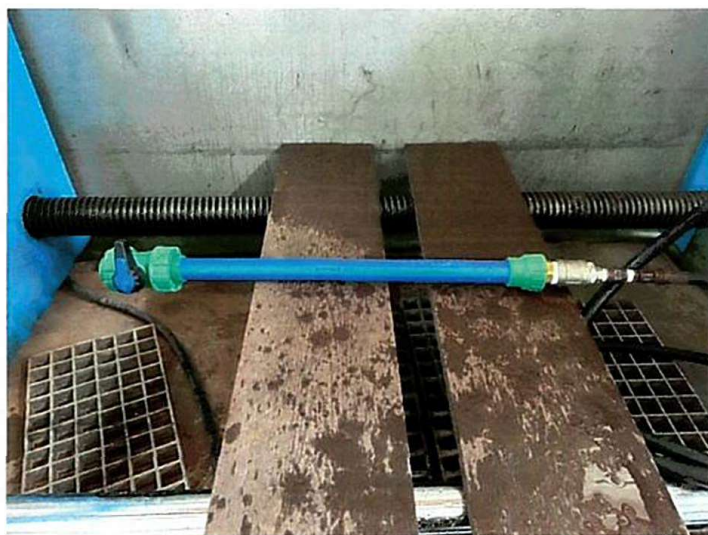
試驗後

試驗項目	試驗結果
爆破水壓壓力(kgf/cm <sup>2</sup> )	62.7

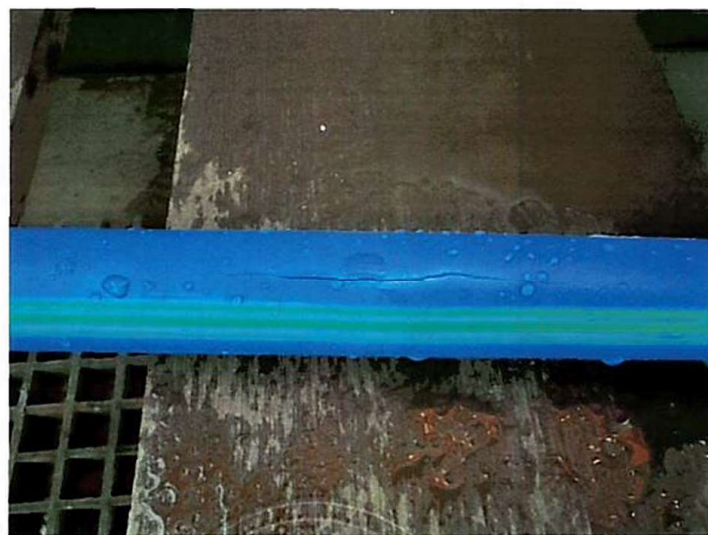
破裂狀態
